EROSION BEHAVIOR AND CONTROL ON A STRIPMINED LATOSOLIC SOIL

**Bessel D. van't Woudt
and
Goro Uehara**

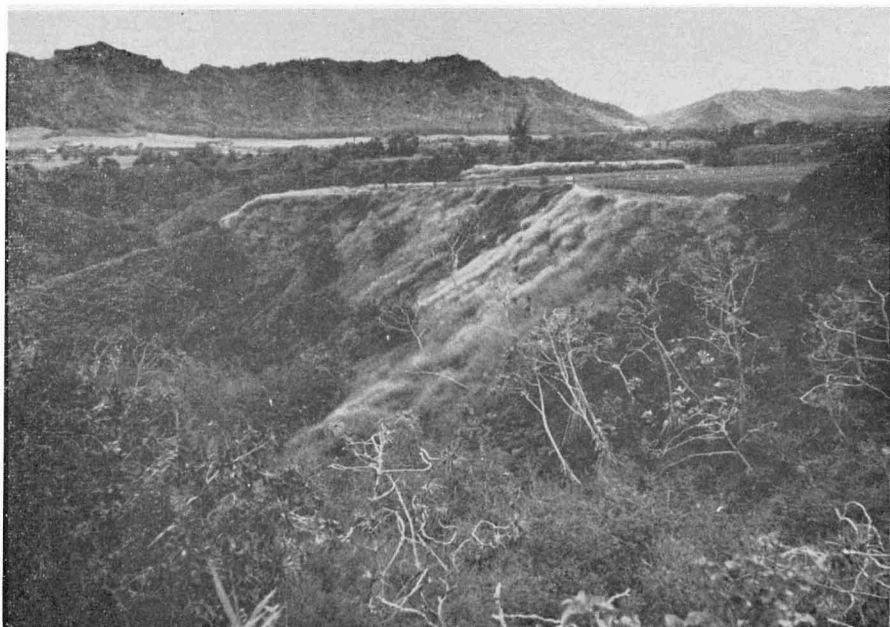
FIG. 1. The stripped ore was pushed by bulldozer onto the slopes of adjacent valleys, creating a severe test of the erodibility of the soil.

bulldozing, pushing the soil over the edge of the ridges onto the slope of adjacent valleys (figure 1). Ultimate slopes were of about the same degree as the original ones, varying from 20 to 30 degrees.

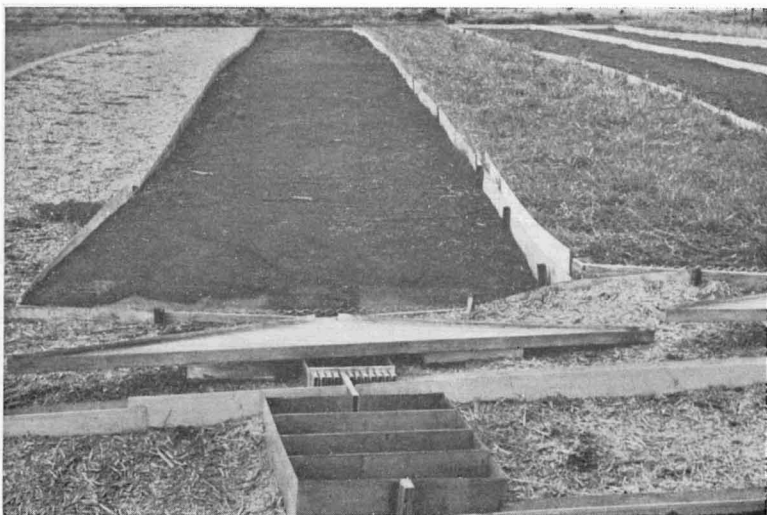
FIG. 11. Soil accumulation in front of the measuring device at the bottom of the plots is induced by the soil-metal boundary. To prevent channeling (see photo) the thus accumulated soil must be removed and be taken into account in soil loss computations.

- (1) The divider box stops proportioning $1/12$ th and $11/12$ th flow by any soil deposition within the slots. Regular inspection of the slots was thus a routine job of the foreman supervising the experimental area.
- (2) Keeping the slots clean necessitated periodic removal of the soil within the divider box and sill.
- (3) Collecting soil accumulated in front of the sill is warranted because,
(a) lack of removal led to channeling through the accumulated soil (figure 11),

- (b) in some places runoff tended to overtop the plot boundary,
- (c) the metal-soil boundary, although inconspicuous to the eye, formed a distinct barrier to soil movement from the plot into the measuring device (figure 11).

The metal stakes inserted for supplying quantitative data on soil displacement on the plots turned out to be useless. The differences between initial and ultimate surface level were so small or so irregularly distributed that no significant trend could be demonstrated on analyses. Only the soil accumulation at the bottom end of the plots with unprotected soil (figure 11) showed up.
